<b>Report for:</b>	<b>Cabinet</b>
<b>Date of meeting:</b>	<b>20<sup>th</sup> April 2021</b>
<b>Part:</b>	<b>Part II</b>
<b>If Part II, reason:</b>	The Part II report contains information relating to the financial or business affairs of the Council.  <b>(Local Government Act 1972, Schedule 12A, Part 1, Paragraph 3).</b>

<b>Title of report:</b>	Highbarns Collapse Feature Remediation Phase
<b>Contact:</b>	Cllr Andrew Williams, Leader of the Council and Portfolio Holder for Corporate and Contracted Services  Author/Responsible Officers:  <ul style="list-style-type: none"> <li>• Ben Hosier, Group Manager Procurement &amp; Contracted Services</li> </ul>
<b>Purpose of report:</b>	<ul style="list-style-type: none"> <li>a) To provide Cabinet with an update on the Highbarns collapse feature, and</li> <li>b) To request financial support for the remediation phase, and</li> <li>c) To highlight the potential financial exposure for the Council.</li> <li>d) To request delegated authority to award a contract for the remediation work.</li> <li>e) To recommend that the Council formally highlights with Central Government and Hertfordshire County Council the potential scale of the risk facing the Coun

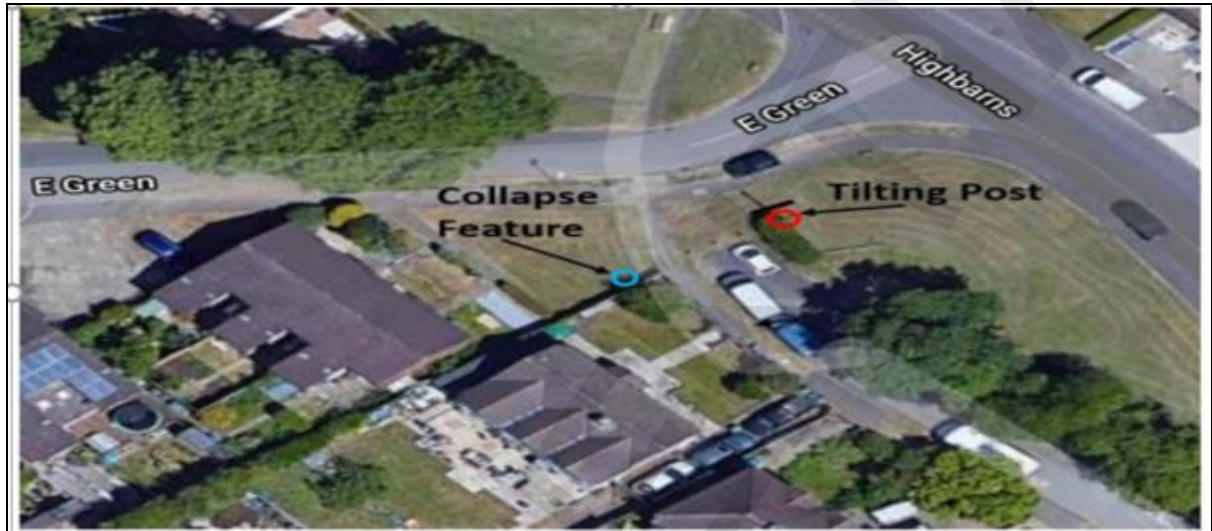
Figure 1 Site layout plan

2.1 A hole appeared in mid-October in an area of public open space adjacent to 4 properties, No.'s 28, 29 & 30 East Green and No. 30 Highbarns. The properties are in private ownership, apart from 30 East Green, which is owned by the Council. The land where the hole is located is Council owned so arrangements for geotechnical engineers to visit the site were made. The collapse has revealed a brick shaft approximately 1.2m in diameter that appears to be a former well (see Figure 1 below)

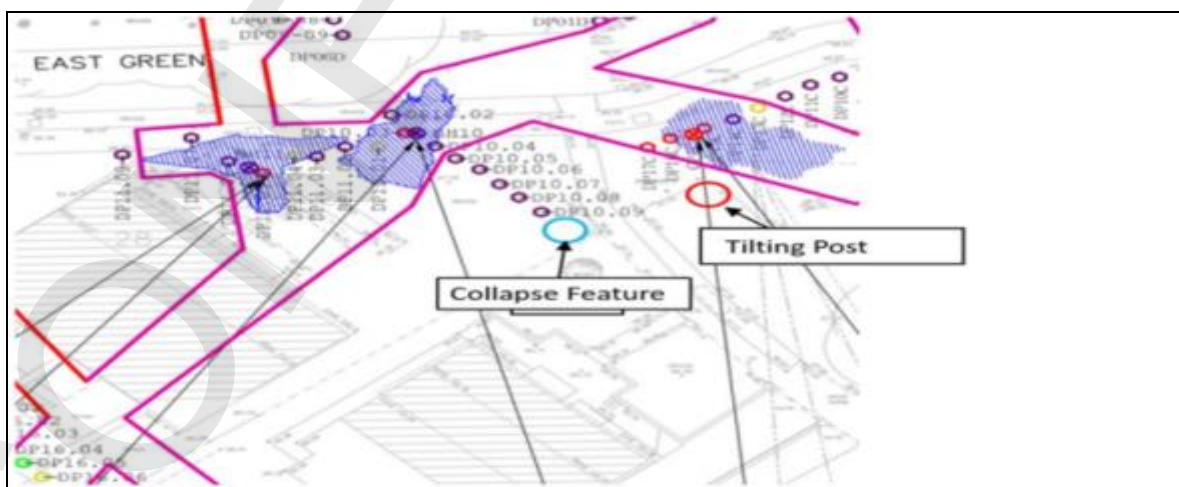
Figure 2 Plan of the extent of the known remediated mine workings (and previous exploratory holes)

3.1 Land close to this area had stabilisation works carried out to it over the past decade. Remediated galleries forming part of the historic Highbarns Chalk Mine are located short distances to the northeast and north-west of the feature (see Figure 2 below – shown hatched purple).

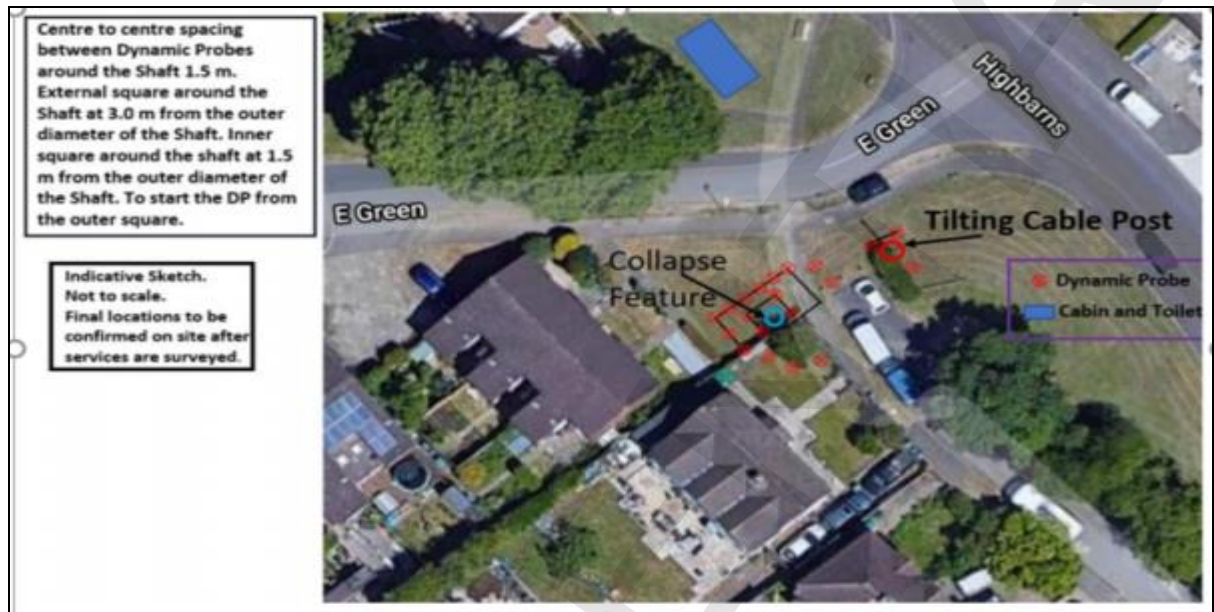
Figure 3 Proposed Ground Investigation Works

4.1 Intrusive ground investigation work was carried out around the collapse feature to ascertain the extent of the sub-surface and loosened ground to enable the design of remedial works. Exploratory holes were drilled around the tilting cable post to determine whether the tilt is related to the subsidence. The Council has kept residents in the properties directly adjacent to this area informed of the situation.

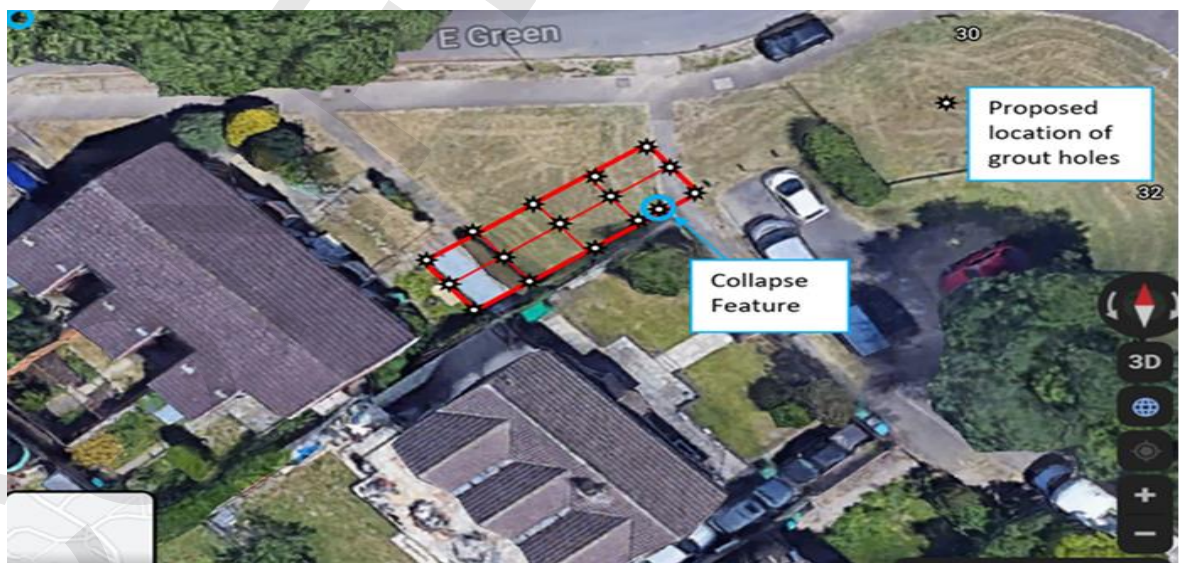
Figure 4 Scope of the identified void

4.2 Initial results of the dynamic probing has identified a void running from the edge of the collapsed feature towards No. 30 East Green, and the lateral and vertical extent of any voided/loosened ground of this void has been identified as being approximately 13.5 m x 4 m.

- vertical compaction grout holes around the collapse to depths of 20m, two inclined grout holes beneath the north-eastern corner of the front garden of No. 30 East Green and a single vertical compaction grout hole located in the centre of the collapse feature to infill the shaft;
- construction of a concrete cap over the shaft/collapse feature.

- 7.2 The recommended remediation method is compaction grouting and bulk infilling both within the shaft and in the vicinity.

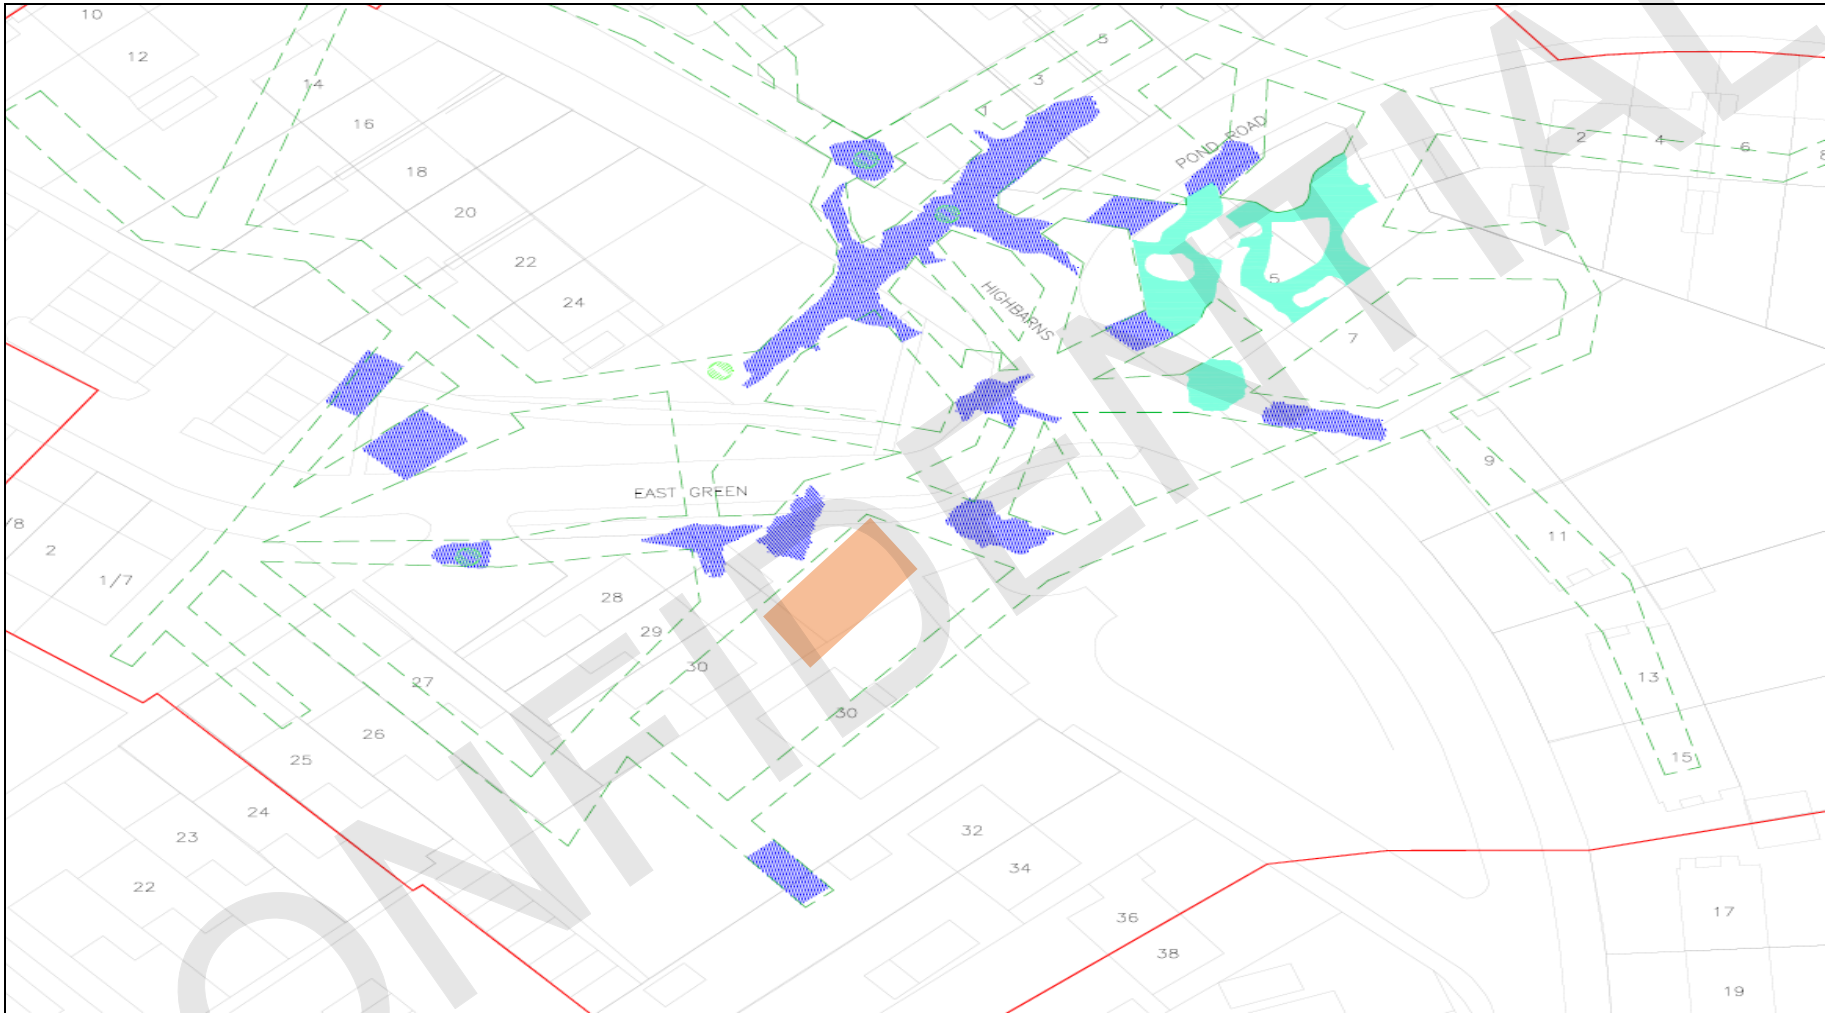
Appendix 3 Interpreted Mine Layout, and the voids that were identified in 2008 and 2012

*The total volume of grout of over 9,000m<sup>3</sup> was used to treat the interpreted mine layout shown on the drawing in appendix 3 including the large open voids identified by boreholes and laser surveys.*
