INTRODUCTION

This report contains the results of a Stage 3 Safety Audit carried out on the above scheme. The Audit was carried out at the request of Mott MacDonald, Cambridge on behalf of Hertfordshire County Council.

1.1 Location – Waterhouse Street

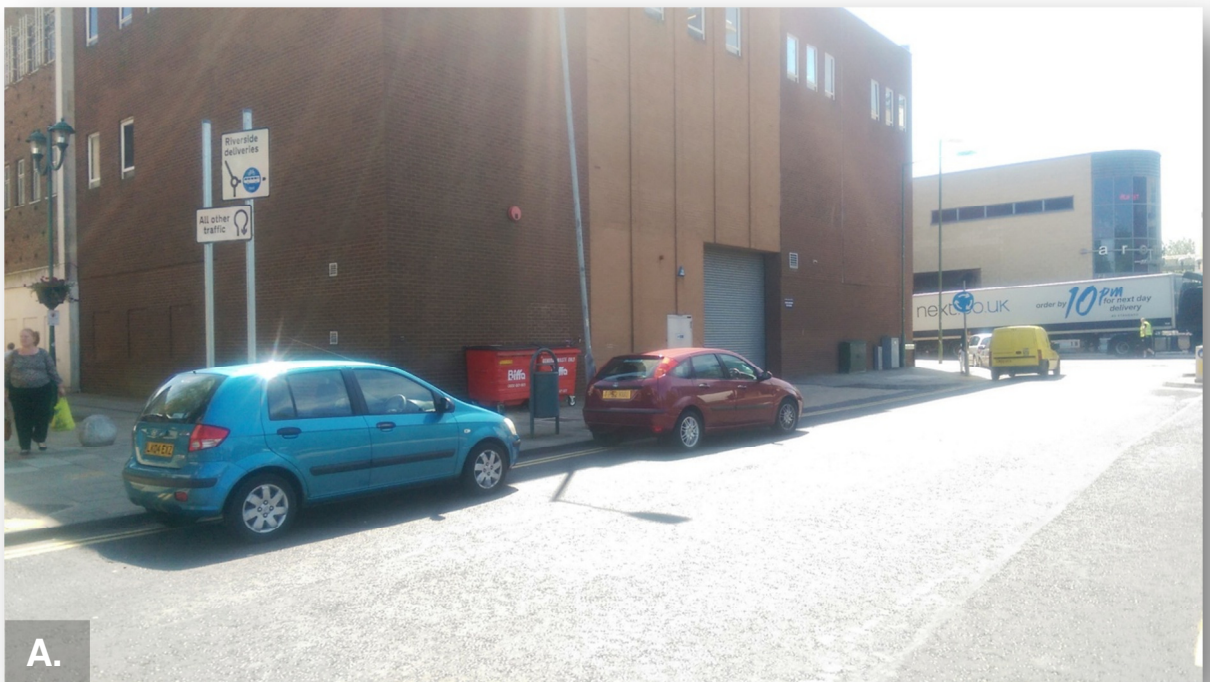
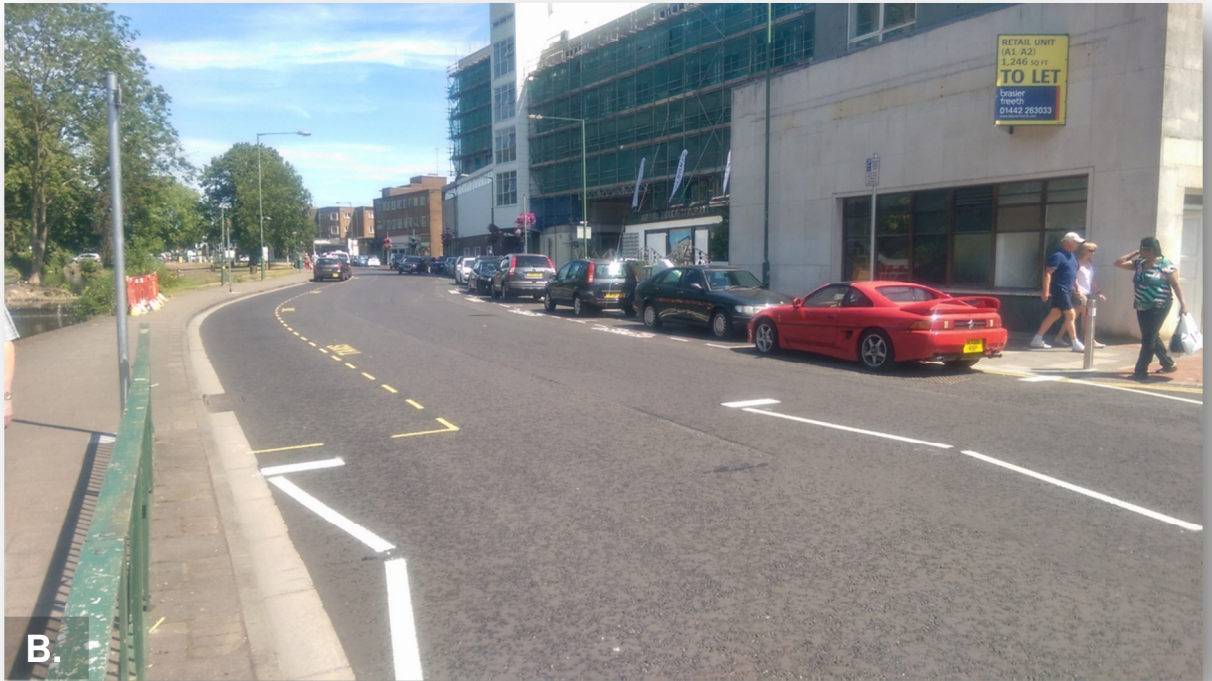
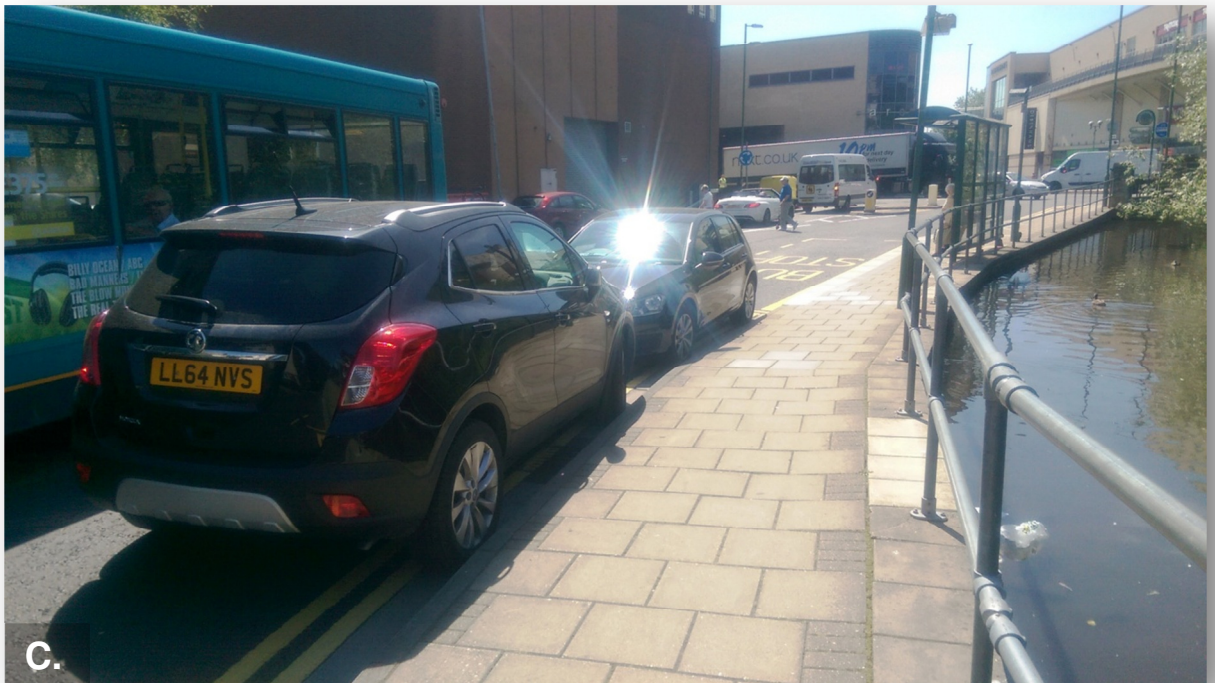
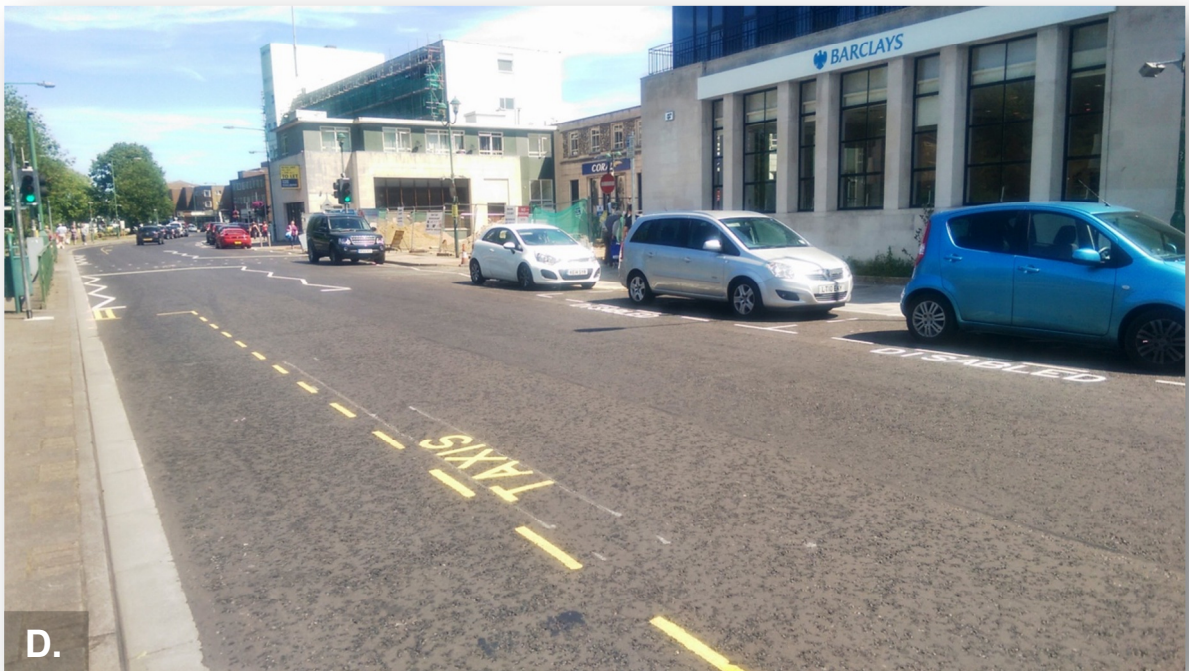
1.2 Location – ‘No Waiting At Any Time’ restrictions on Waterhouse Street

Problem – Location of Green Badge Parking raises risk of conflict

The Waterhouse Street Scheme has seen the replacement of several disabled parking bays with taxi ranks. Although some disabled bays are retained, there is a net loss and during the site visit demand far exceeded capacity. As a consequence the majority of the short sections of ‘No Waiting At Any Time’ restrictions were used by Blue Badge Holders. Several of these are at locations which hinder access or raise the possibility of conflict, such as adjacent to pedestrian or vehicular accesses, or immediately next to bus stops. Conversely, long lengths of taxi rank were unoccupied. Illegal and potentially unsafe parking was also observed by non-Blue Badge holders on pedestrian crossing zig zags and at pedestrian accesses.

Recommendation

It is understood that alternative disabled parking provision is located within the nearby car parks. It is recommended that dialogue takes place with local disabled user groups to highlight this and encourage alternative parking arrangements. It is also recommended that enhanced parking enforcement is undertaken to deter any illegal and unsafe parking.

During the site visit, the long lengths of empty taxi rank suggested an appropriate balance of parking provision may not have been struck on Waterhouse Street. It is accepted that at other times, such as Saturdays and around Christmas, that demand for taxis is likely to be higher. Nevertheless, it would be prudent to review usage of the various parking bays and restrictions after 6 months and consider re-allocation as required.

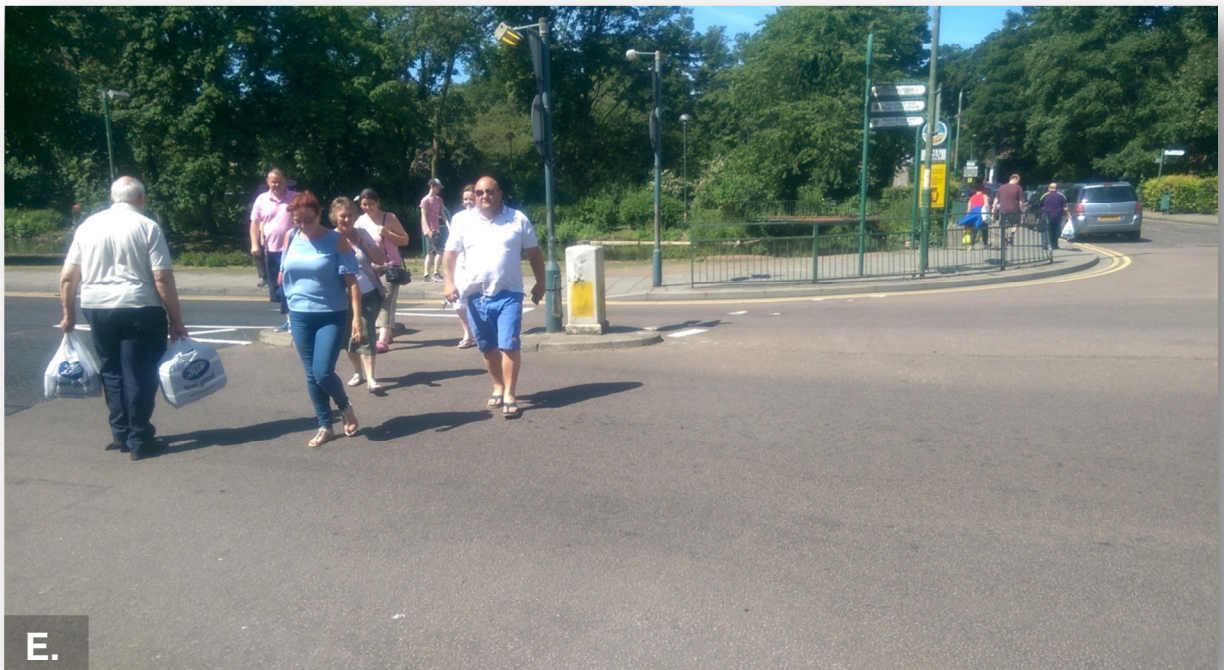
4.1 Location – Waterhouse Street/Bridge Street

Problem – Inadequate crossing facilities increase risk of pedestrian/vehicle conflict

The existing pedestrian refuge island at the north end of the Waterhouse Street scheme is narrow, at approximately 1.5m in width. This is a key pedestrian desire line for access to The Marlowes from car parks and the head of the taxi rank. Site observations indicate that the existing refuge is too small to accommodate groups of pedestrians and there is an increased risk of pedestrians being struck by passing traffic. The Designer's response to the Stage 1/2 Safety Audit stated that analysis would be undertaken to establish whether a larger island could be accommodated, although this has not been confirmed.

Recommendation

Provide a wider 1.8m pedestrian refuge and delineated contrasting surface, similar to that on the Bridge Street arm of the mini roundabout to highlight the crossing. Two rows of buff coloured tactile paving should be provided at the crossing point to aid partially sighted users.
